# Comparative structural analysis of polyurethane and silicone catheters of totally implantable venous access devices by micro-computed tomography

SAGE Open Medicine

DOI: 10.1177/20503121211059949

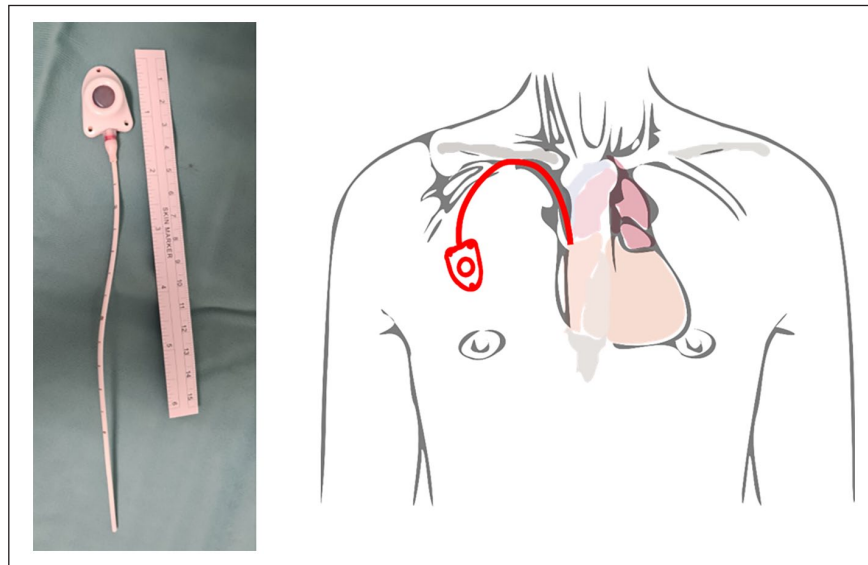
**Figure 1.** A real TIVAD (left) and a sketch showing its final positioning (right).

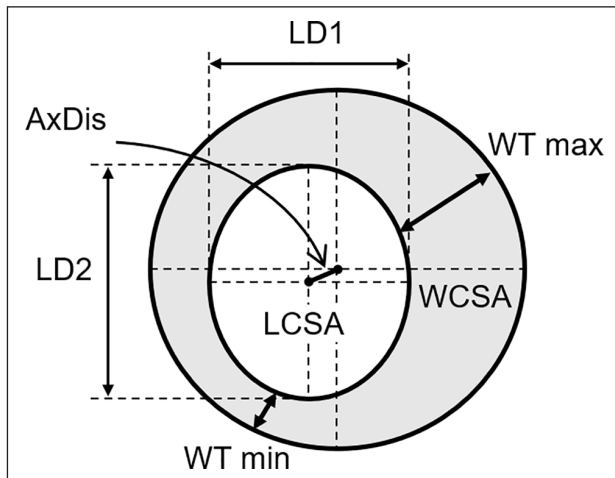
**Figure 2.** Conceptual scheme of the CVC cross section, with meaning of the geometrical parameters under investigation in this study. The drawing has been done with exaggerated WT variations and displacement between axes, in order to facilitate the visual understanding of the parameters.

Catheter segments on each bundle were independently analyzed using ImageJ ver. 1.53d (NIH, Bethesda, MD, USA).<sup>23</sup> Morphological analysis included the main parameters having a direct effect on mechanical resistance, such as catheter wall thickness (WT), wall cross-section area (WCSA) lumen minimum and maximum diameter (LD1 and LD2, respectively), lumen cross-section area (LCSA), displacement between axes of inner and outer surfaces (AxDis), as shown in Figure 2. Catheter section geometry was assessed

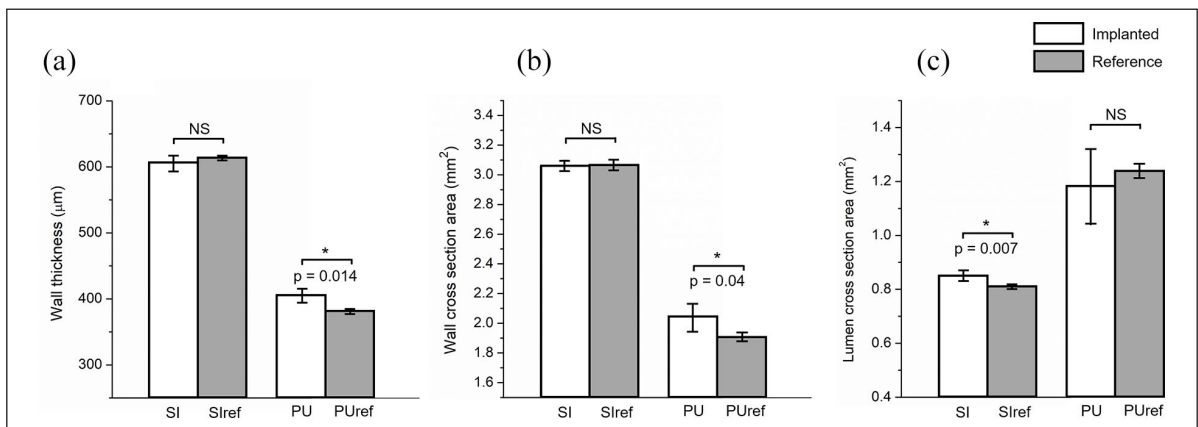
**Figure 3.** Main morphological parameters showing changes between the implanted group and the reference group: (a) WT, (b) WCSA, and (c) LCSA.

From a macroscopic point of view, the observation of the analyzed segments of CVC did not reveal evident abnormalities, ruptures or failures. The micro-CT quantitative morphometry has shown, as expected, the different section geometry between silicone and polyurethane catheters due to the different nominal caliber (6.5Fr for SI and SIref groups and 6Fr for PU and PUref groups, respectively). Analysis results are reported in Table 2. The graphs in Figure 3 highlight the main morphological changes observed between implanted and non-implanted catheters, for the two materials. While comparing implanted CVC morphology with corresponding control (reference) groups, we have observed that SI group showed increased luminal cross-section area with respect to SIref ( $LCSA = 0.851 \pm 0.020 \text{ mm}^2$  in SI vs  $0.811 \pm 0.007 \text{ mm}^2$  in SIref,  $p = 0.007$ ). This change is related to the increased luminal diameter of the SI CVCs with respect to their controls ( $LD1 = 1032 \pm 11 \mu\text{m}$  in SI vs  $1014 \pm 6 \mu\text{m}$  in SIref,  $p = 0.02$ ). This small ( $< 20 \mu\text{m}$ ) diameter increase could suggest a drug-related erosion of the catheter material, even though we cannot exclude differences due to different batches of the catheters. We have also noticed an increased WT and WCSA in the polyurethane group as compared with the reference CVCs of the same materials ( $WT = 403 \pm 12 \mu\text{m}$  in PU vs  $382 \pm 4 \mu\text{m}$  in PUref,  $p = 0.014$ ;  $WCSA: 2.04 \pm 0.09 \text{ mm}^2$  in PU vs  $1.91 \pm 0.03 \text{ mm}^2$  in PUref,  $p = 0.04$ ), whereas no significant changes of the luminal diameters and area have been observed for this material. The increased thickness in implanted PU CVCs can not be only explained by the presence of biofilms, which in general have much lower thicknesses.

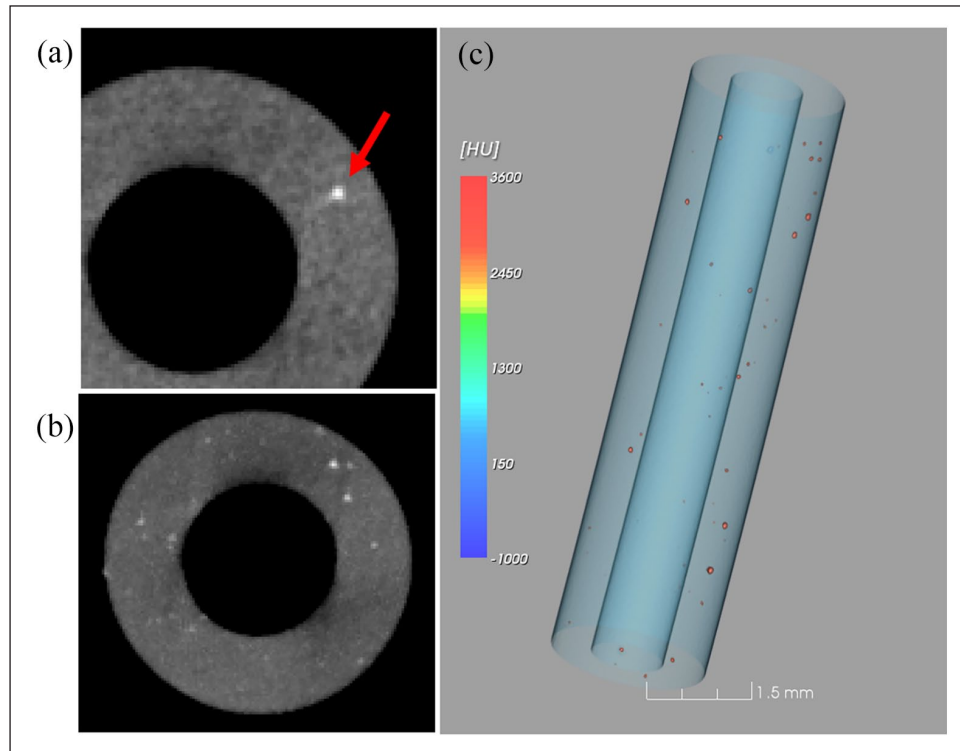
**Figure 5.** Severe-scored CVC for presence of hyperdense particles (S2 sample). (a) Micro-CT slice of the catheter (voxel size = slice thickness = 18.4  $\mu\text{m}$ ), passing through a hyperdense spot. (b) Maximum intensity projection (MIP) of the same sample in (a), integrated over 1 mm along the catheter axis, showing how frequently particles appear in the sample. (c) 3D volume rendering of the same sample, showing the hyperdense particles as red dots.

The local defect analysis showed different patterns between the two types of materials. All CVCs in this study presented hyperdense particles inside the wall. The observed (apparent) diameter of such particles ranged from 20 to  $100 \mu\text{m}$  and have been found at random depths within the catheter wall. Six out of nine silicone catheters were affected by  $> 1$  particle/cm, and two of them were scored as “severe” for this type of defect. On the other hand, only few smaller particles have been found in the polyurethane group. Figure 5 shows how these dense spots are distributed in one severe case.
